EARTH MORTARS RESEARCH PROJECT

Stage 1: Knowledge Review & Research Strategy

HISTORIC
ENVIRONMENT
SCOTLAND

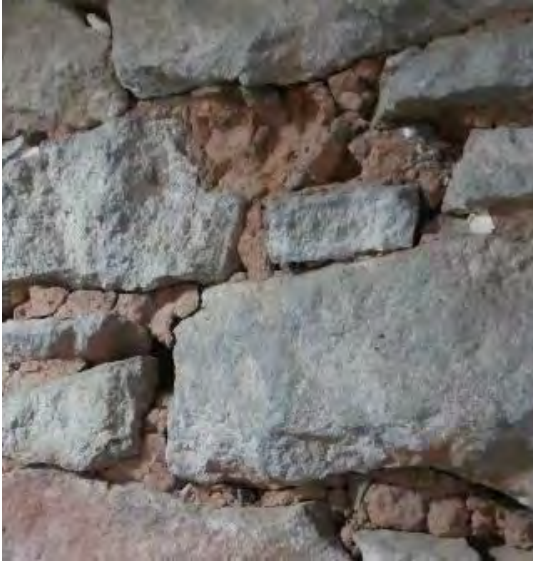
Fig. 5: Example of earth mortar, used as dug, from very close to site, Main St. Longforgan, early 19th C. Shrinkage cracks as a result of high clay content in chimney wall.

Fig. 15: The village of Longforgan was ‘built with turf and stone or clay for mortar, and not a vestige of lime’ before 1777 (OSA). Soon after, all were replaced by the landowner with smarter buildings, built of earth mortared masonry pointed in lime. See Figs 5 & 6.

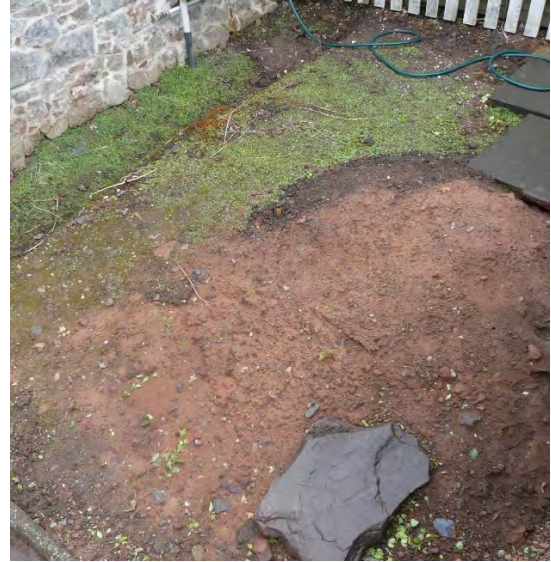
Fig. 6: Stirling series soil, in rear garden of house, note external lime pointing.

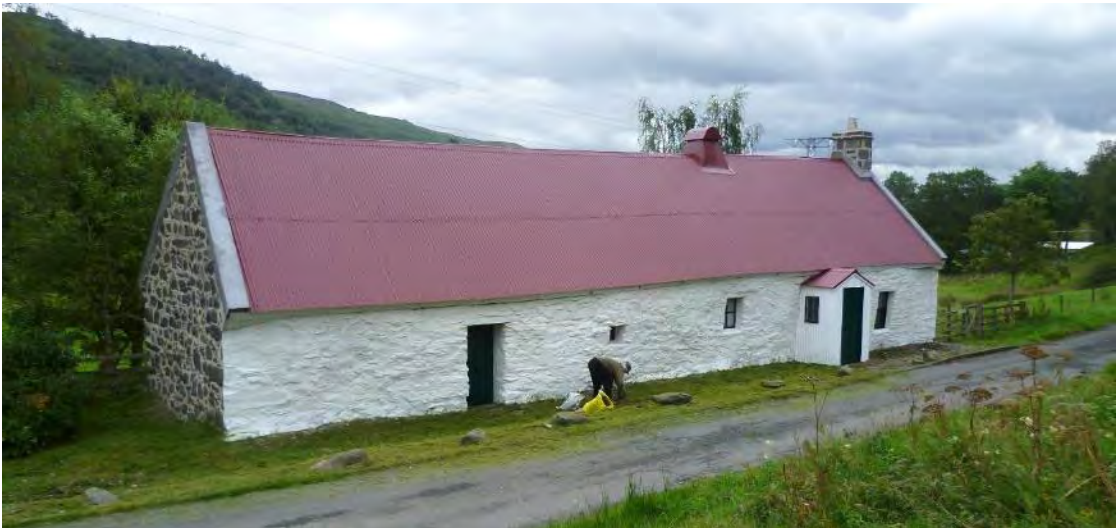
Fig. 7: Moirlanich Longhouse, weak earth mortared rubble with lime pointing & wash. The leaning section to the right of the porch is shown in repair below.

In some places, the use of local soils meant that some very weak mortars were used. The weakest earth mortar we are aware of is at Moirlanich Longhouse, a rubble masonry structure near Killin, where the mortar is silty/peaty and has negligible strength. Such structures rely on good masonry technique, with stone-to-stone contact and through stones binding the inner and outer leaves to resist movement. The mortar provides cushioning and air-tightness. Such mortars rely on protective weathering coatings to the outside, usually lime pointing or renders.

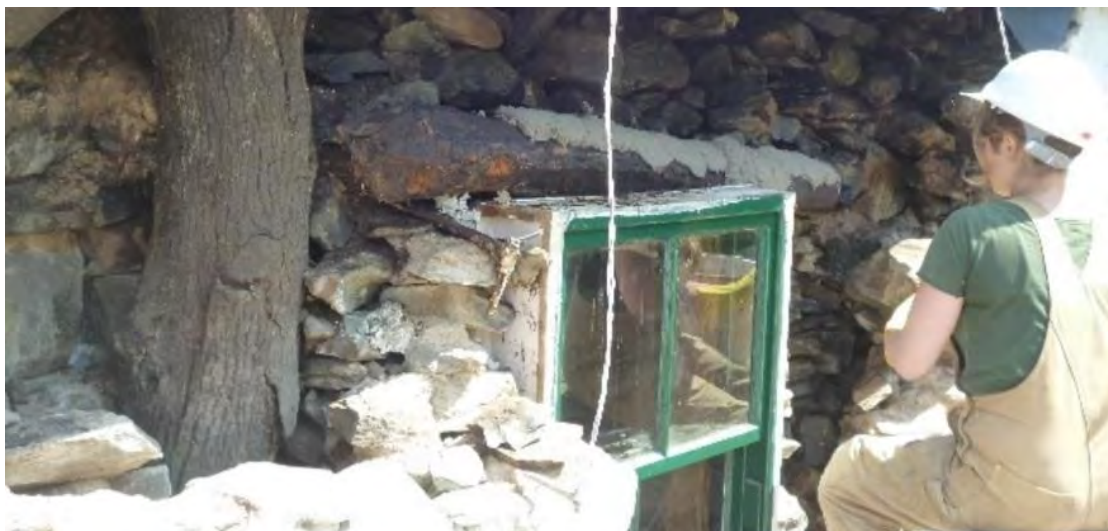
Fig. 8: Back face of inner leaf exposed during repairs at Moirlanich, with cruck leg having benefitted from the preserving effect of earth mortar drawing away moisture.

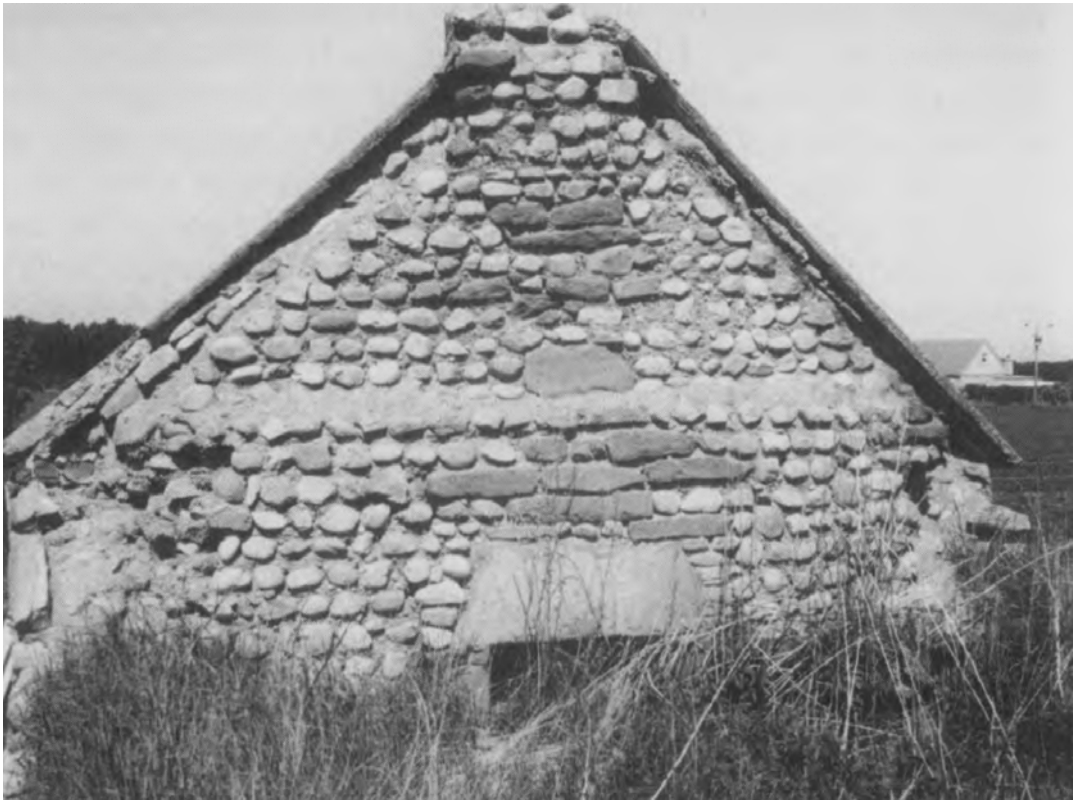
Fig. 9: Clay and Bool wall, Cowfurach, Moray. © HES. Similar arrangements of round river stones laid in herring-bone rows can be found in other countries.

As at Cowfurach, Rathven, the 'bools' are laid in neat rows (Fig.9) in a shed on Longhill Mill, Urquhart, they are in a herring-bone pattern. Most of the cottages at Kingston-on-Spey, built initially at the end of the 18th century to house workers in the ship building and timber industries there and at Garmouth, are of clay and bool. The material was used for simple linear steadings at Bogmuir and considered in 1820 for a 'Square of offices' to be built at Edom, Pluscarden. Here the farmer, Mr. Bain, when advertising for tenders for the work, stated that he would provide the materials but 'as it is not yet decided whether the offices will be of Mason or Achainhalrig (sic) Work, Contractors are requested to estimate for these different works separately'.

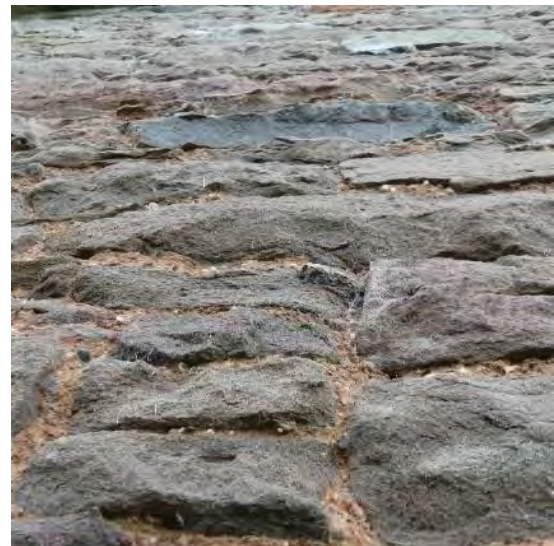
Fig. 11: Detail of earth-lime mortar.

While there remains only the faintest traces of the original lime harl, there has been practically no decay of the earth-lime mortar, showing that it has significantly outperformed a richer lime material for durability, probably because it has hydraulic reaction.

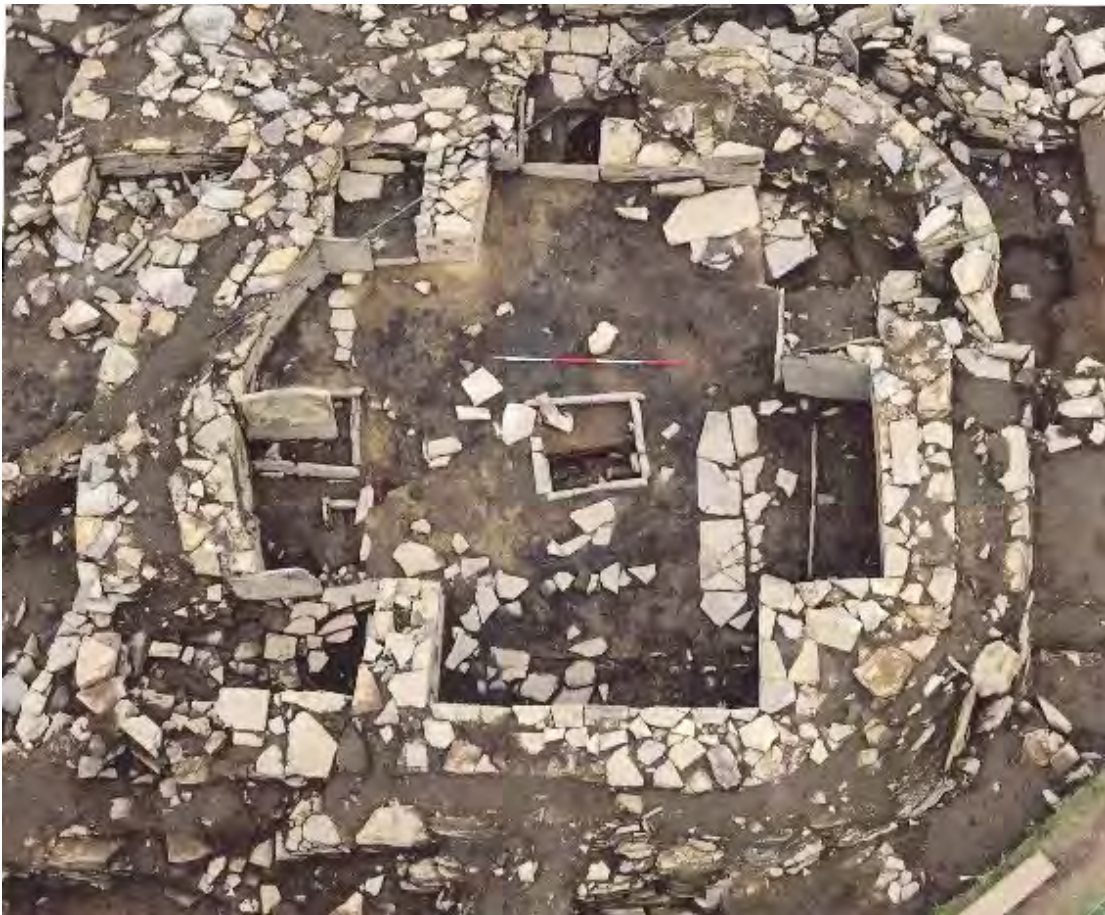
Fig. 12: Part of the emerging Knap of Brodgar complex, with clay floor and mortared masonry walls. © Hugo Anderson-Whymark.

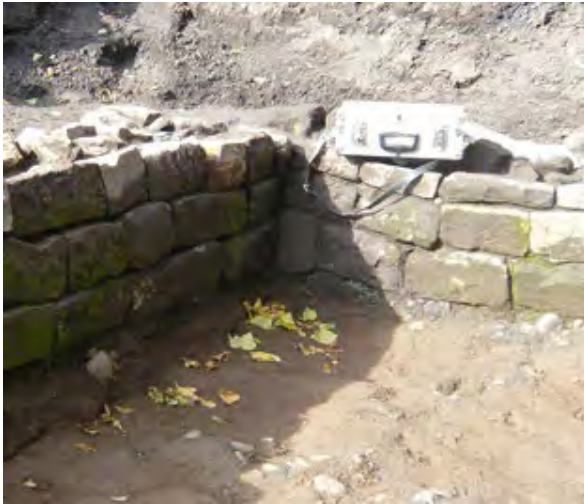
Fig. 13: Roman masonry at Crammond.

Parts of Hadrian's Wall are earth-mortared masonry and significant remains survive at Cramond and other sites in Scotland. At Cramond, several courses of dressed stone are laid in a strong clay earth, though the source was not identified or the degree of

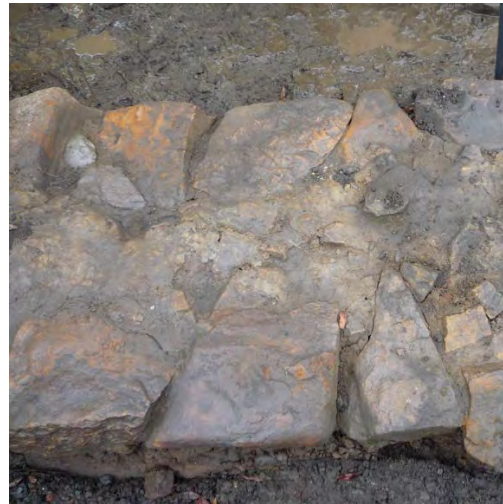
Fig. 14: Earth mortar, note no lime.

any alteration from the dug material. There was no evidence of lime mortar pointing (Little). The Roman complex at Bearsden has similar earth-mortared masonry with no record of lime².

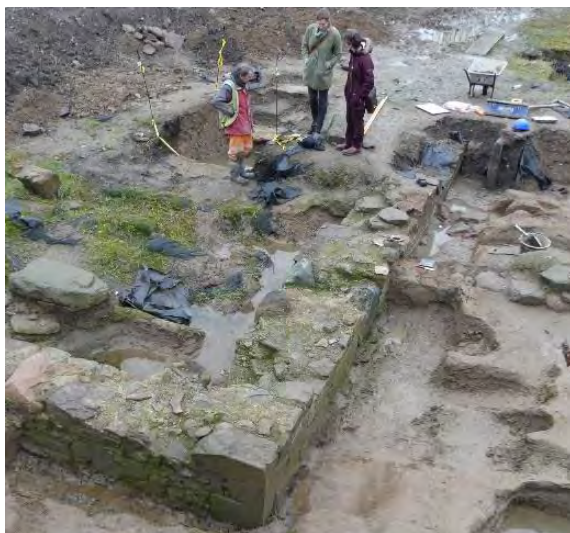
Fig. 15: Carmelite Friary, Perth, earth mortared wall bases, may have had lime mortared masonry above.

There is some evidence supporting a view that some foundations were earth mortared to provided damp-proofing to lime mortared masonry above. This seems to especially occur in the later sites, but there is insufficient evidence to determine whether this was a systematic approach specifically using an expansive clay. This would merit further research.

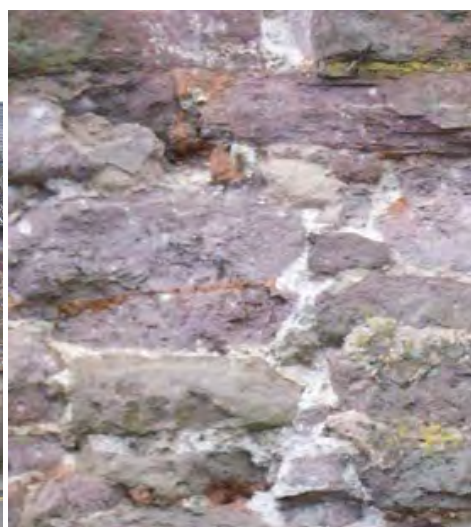
Fig. 17: Earth mortar core, lime pointing

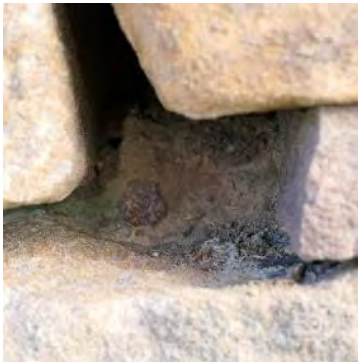
Fig. 18: Earth mortar, severe external decay.

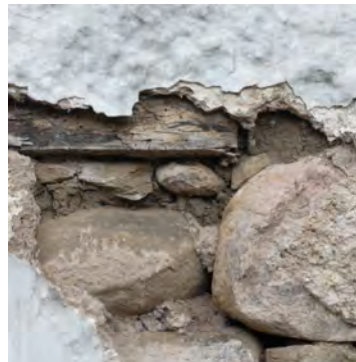
Fig. 19: Earth mortar concealed behind lime finishes.

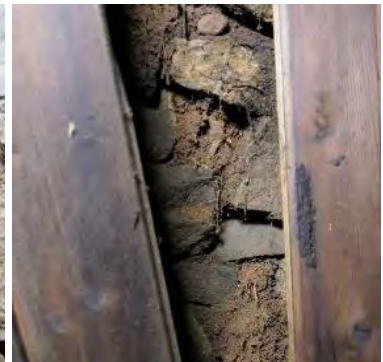
Fig. 20: Earth mortar concealed behind internal linings.

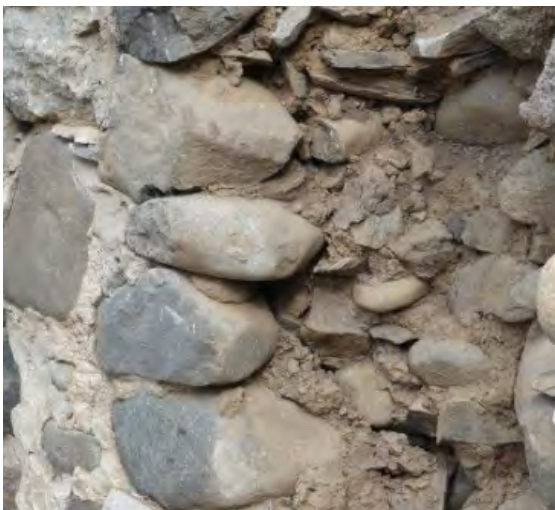
Fig. 21: Earth-mortared wall with lime pointing, the face having fallen away due to water ingress at the wallhead and lack of restraining through stones tying the outer to the inner face.

In addition, the relatively low tensile strength of earth mortars compared to lime mortars, can lead to a mis-reading of how a masonry element will perform when exposed to decay mechanisms. Earth mortared structures rely on good masonry technique. The absence of through stones connecting faces is a key vulnerability not always apparent.

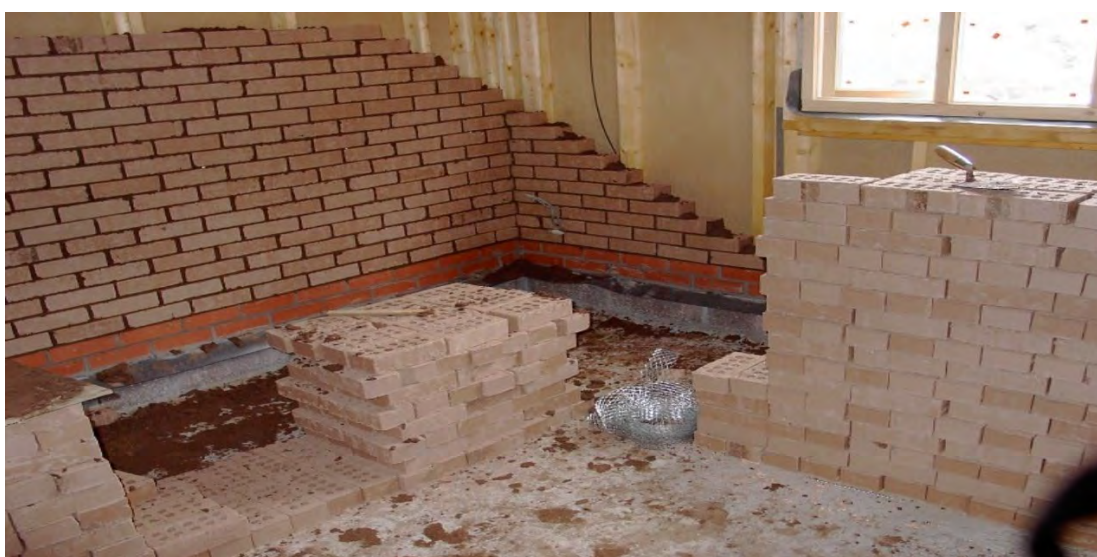
Fig. 22: Earth mortar in contemporary eco-house, Perthshire.

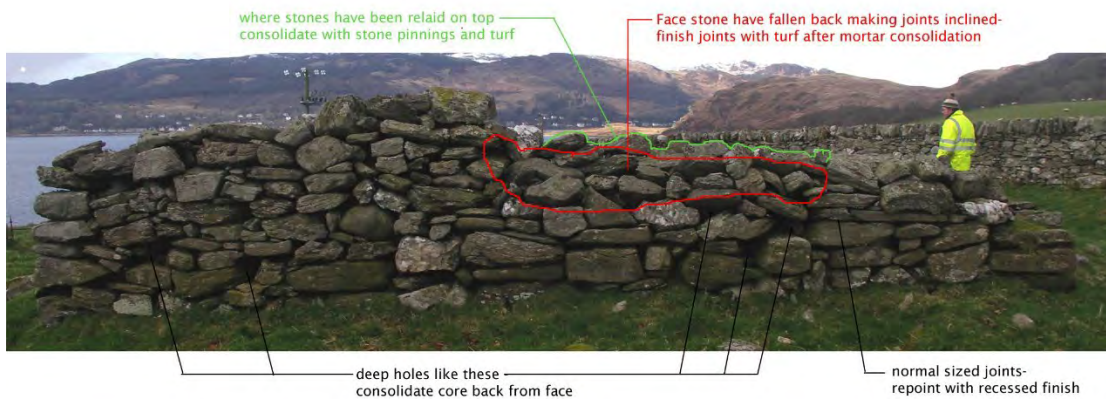
Fig. 21: 9th C. Kilmichel Chapel, Bute, prior to repairs.

A good example is the Archaeologist on the Discover Bute Landscape Heritage Project, who led the repair of 2 ruined early Christian chapels, which had previously been wrongly recorded as unmortared, but were very clearly earth-mortared. This led to the appropriate repair of the sites using local earth mortar.

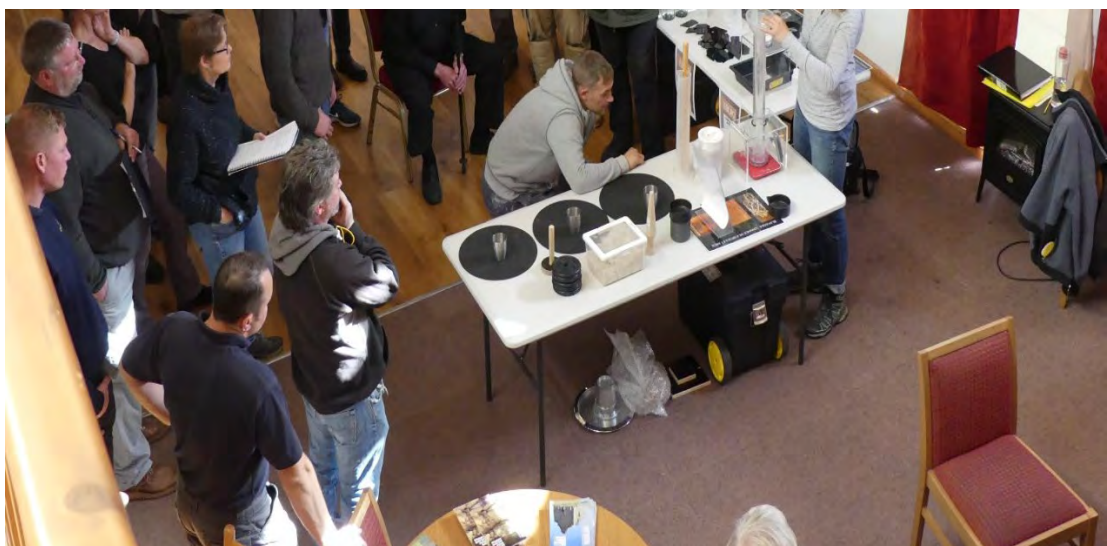
Fig. 22: Blended earth mortar training event for architects and contractors, Northumberland.

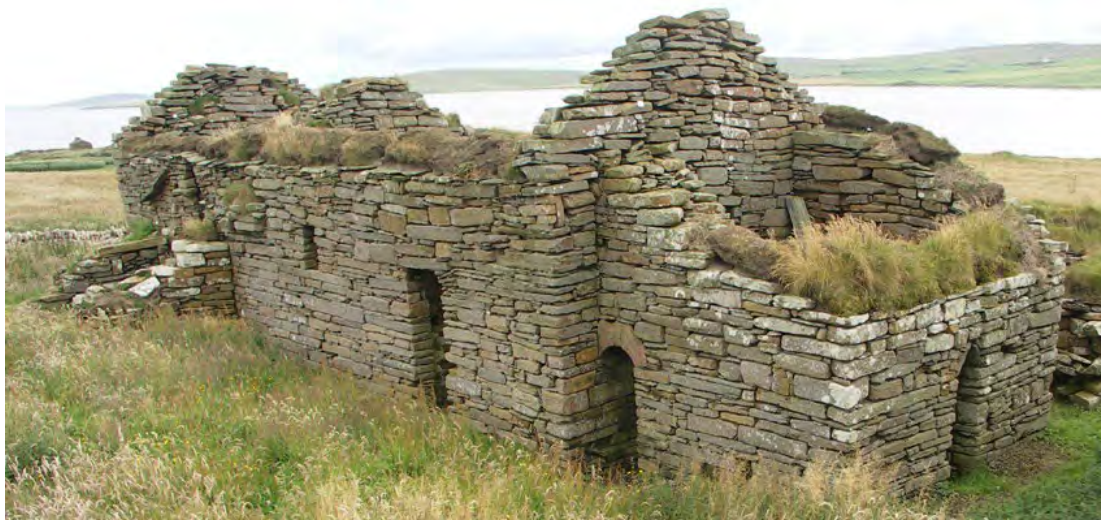
Fig. 23: Eynhallow Monastery, Orkney, movement of masonry followed erosion of earth mortar.

The HES Soft Cappings In Scotland Research Report (2015) included the 12th century scheduled monument of Eynhallow Monastery as a case study, highlighting how the structure was clearly earth mortared but was being repaired and maintained using drystone techniques, resulting in a fundamental change in the appearance of the monument and a reduction of its structural stability and material integrity.
